*Technical Memorandum 33-517*

*Development of an Adhesively Bonded Beryllium  
Propulsion Structure for the Mariner  
Mars 1971 Spacecraft*

**JET PROPULSION LABORATORY  
CALIFORNIA INSTITUTE OF TECHNOLOGY  
PASADENA, CALIFORNIA**

January 1, 1972

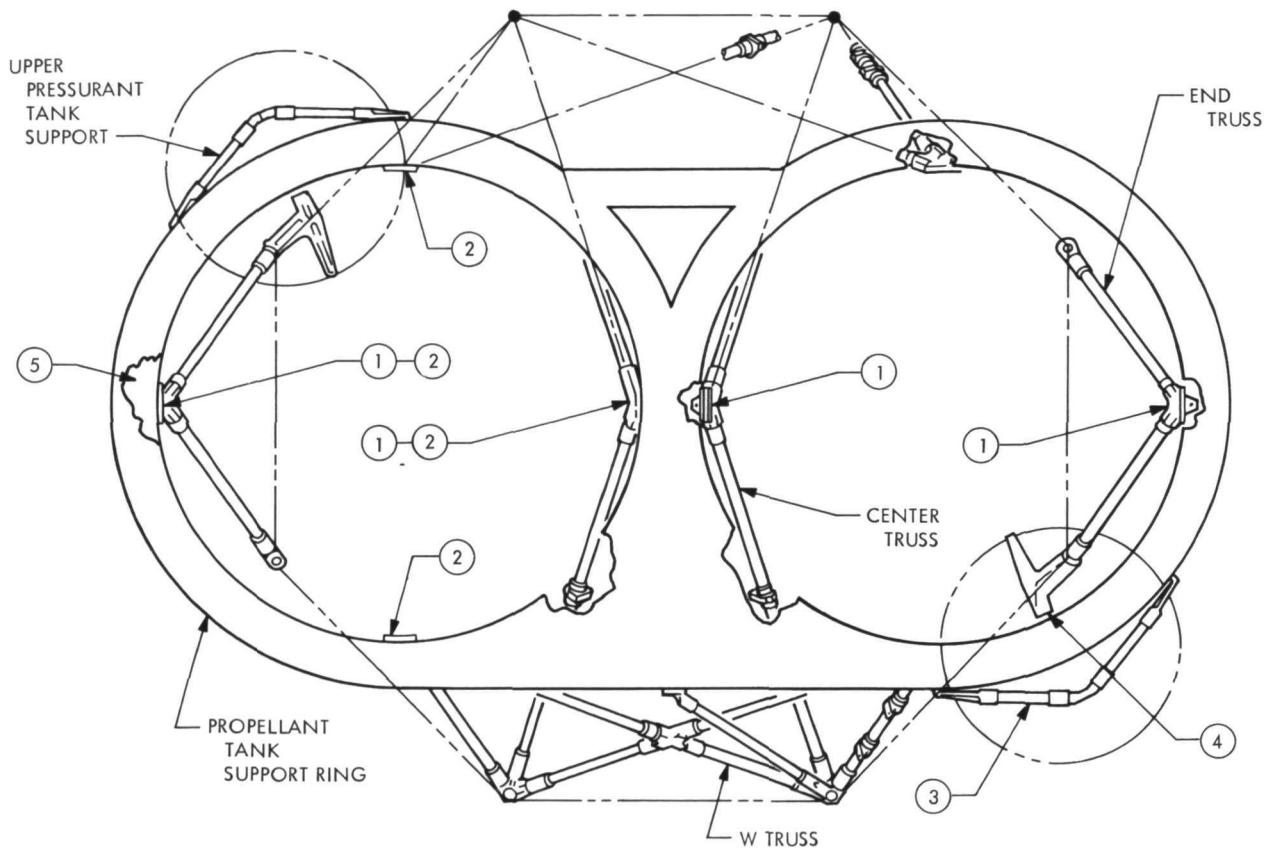
Fig. 11. Support structure failure locations

During system-level forced vibration testing, several structural weaknesses were revealed. Four magnesium fittings cracked and one failed at a stress riser resulting from an insufficient fillet radius. Several more failed because of an overtest condition in which input levels were twice as great as planned. Still another magnesium fitting and a beryllium tube in the pressurant tank support fractured because of higher than anticipated response at the tank's natural frequency. A friction joint proved inadequate when a materials change in the joint resulted in a lower coefficient of friction.

The following sections cover in more detail the problems mentioned above. In Fig. 11 the location of each is indicated along with a reference designator that refers to the appropriate section.

- ① CRACKED FITTINGS - INSUFFICIENT FILLET RADIUS
- ② BROKEN FITTINGS - OVERTEST
- ③ BROKEN BERYLLIUM TUBE - OVERSTRESSED
- ④ CRACKED FITTING - IMPROPER GRAIN ORIENTATION
- ⑤ RING/TRUSS JOINT SLIPPAGE - LOW COEFFICIENT OF FRICTION

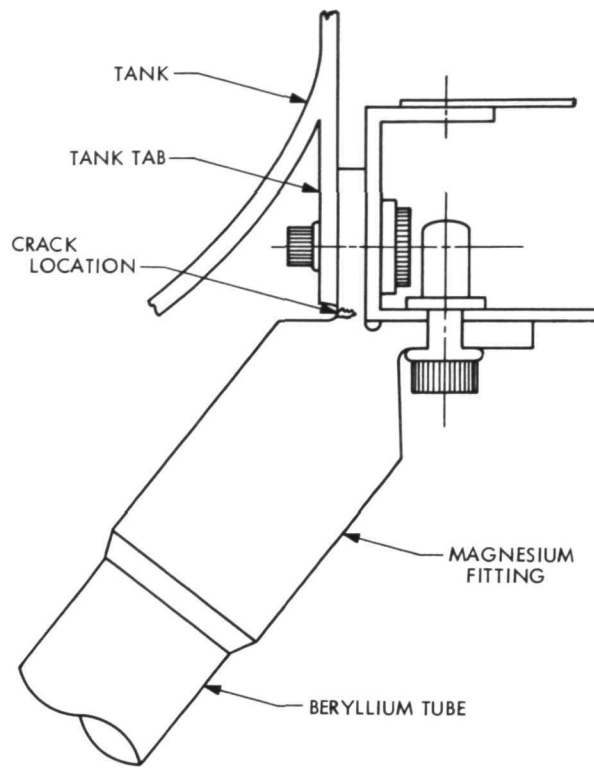
Fig. 12. Fitting crack location

During developmental test model (DTM) system-level vibration testing, the upper fitting on one of the end trusses fractured. The bipod containing the broken fitting was replaced and testing continued. After the test, all fittings were examined microscopically. Four upper fittings (① in Fig. 11) (both center and both end bipods) exhibited hairline cracks in the fillet radius at the base of the vertical flange (Fig. 12). Analysis showed that an unsatisfactory root radius [less than 0.76 mm (0.030 in.)] had produced a stress concentration factor greater than two. A shortcut in milling machine cutter grinding resulted in a 45° sloped fillet rather than the radius called for on the drawing. All center- and end-truss upper fittings were modified to increase the root radius to 2.28 mm (0.090 in.) (Fig. 13).

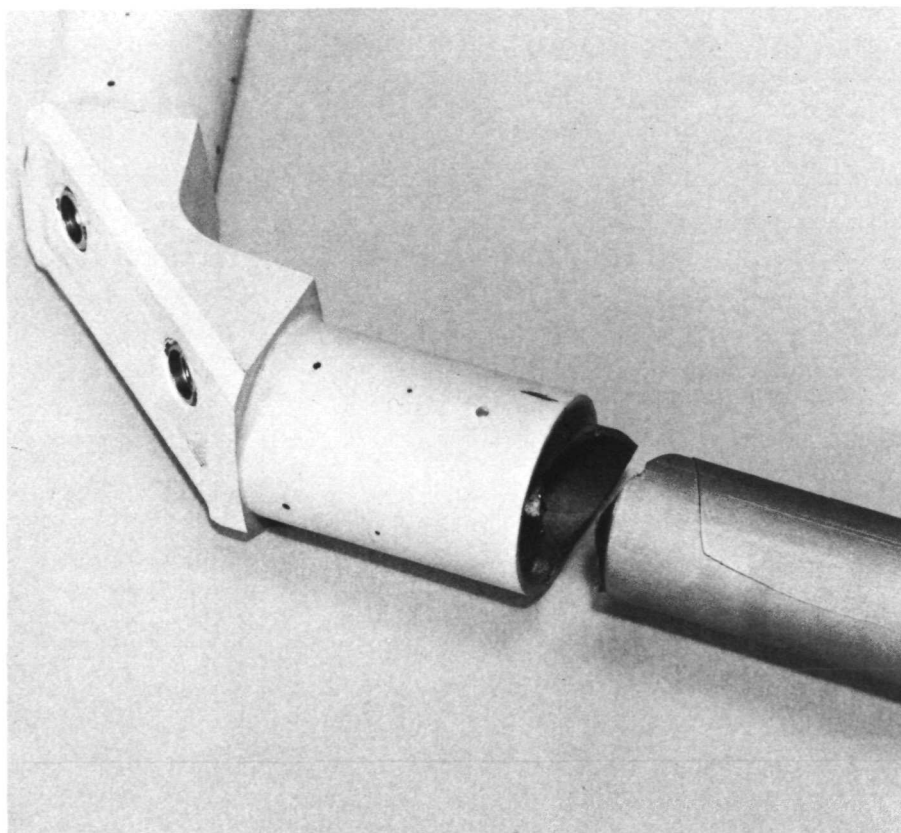
Fig. 14. Upper N<sub>2</sub> tank support tube fracture

In an auxiliary truss that supports the N<sub>2</sub> pressurant bottle, a beryllium-tube failure did occur. Subsequent analysis of the vibration test results revealed that the torsional response of the N<sub>2</sub> bottle at its natural frequency was significantly higher than anticipated. The resultant tube loading exceeded the statistically determined design allowable by 30 to 50% as shown in Fig. 6. Beryllium tubes in the pressurant tank supports were replaced with steel tubing and testing was concluded without further incident.

Difficulty was experienced with both upper and lower pressurant tank supports ((3) and (4) in Fig. 11) during subsystem-level forced vibration testing. During the TA subsystem test, one of the four beryllium tubes in the upper support fractured (Fig. 14) (Ref. Subsection IV-B-2). Following the DTM subsystem test, both lower fittings were found to be cracked (Fig. 15). Both difficulties resulted from excessive stress induced by unexpectedly high response of the N<sub>2</sub> bottle at its fundamental resonant frequency. The subsystem-level test environment was found to be approximately 50% more severe than that experienced in previously performed system-level tests.

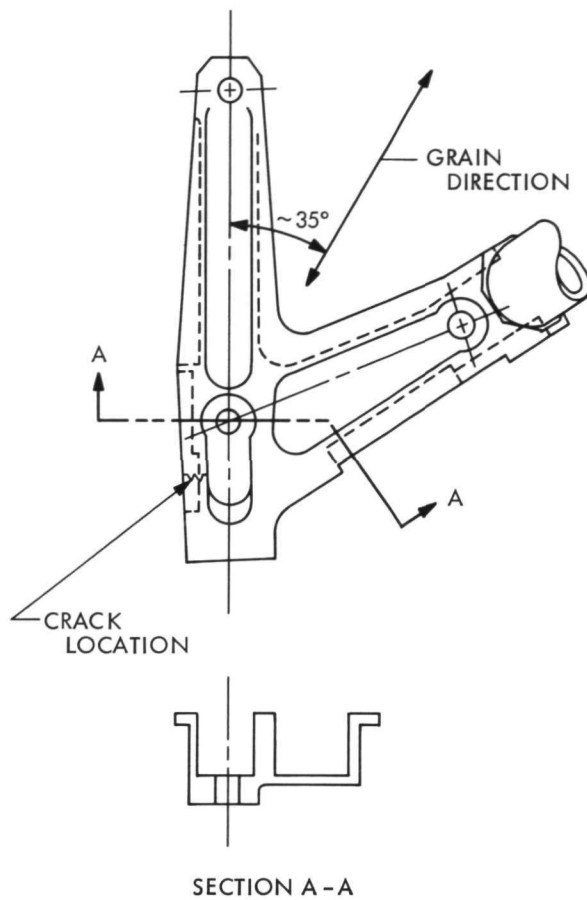
Fig. 15. Lower  $N_2$  tank support — original configuration

Another factor that may have contributed to the fitting failure was a probable reduction in the mechanical properties of the fitting material (ZK60-T5 extruded magnesium bar). Tests performed subsequent to the failure indicated that an approximate 25% reduction in low cycle fatigue life, could be expected in Dow 17-treated thin-section magnesium parts.

Fitting-material tests also indicated an approximate reduction of 45% could be expected in tensile yield when grain direction was oriented normal to the principal stress axis. Since grain direction was inadvertently omitted on the drawing, parts were machined in the orientation that required the least raw material. As shown in Fig. 15, the grain direction was approximately 35° off the axis of load application. The fitting was

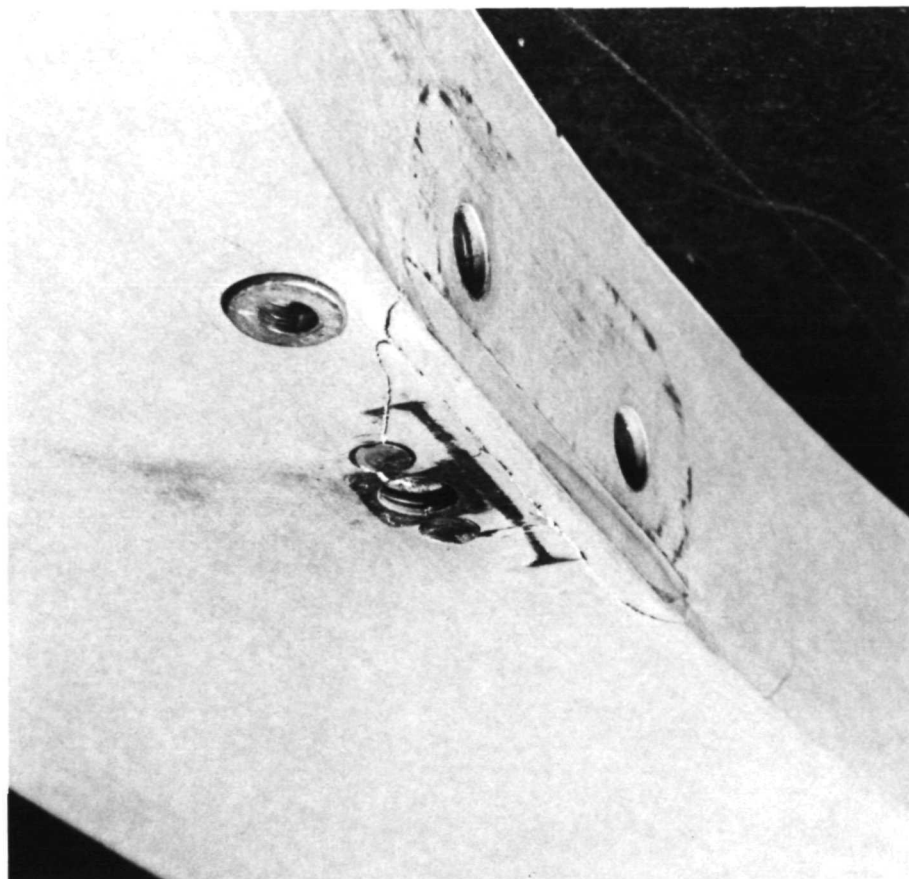
Fig. 17. Ring/truss joint damage

When four of the upper truss fittings were changed from magnesium to steel, an approximate 40% reduction in coefficient of friction resulted. During system-level testing, one of the friction joints failed ((5) in Fig. 11). Ring damage sustained was severe but localized, and the structure maintained its overall integrity (its ability to securely support the propulsion subsystem). The lower and inner webs of the ring were fractured in the area of interface with the end bipod upper fitting. Severe galling of the under surface of the ring was also evident. Figure 17 depicts the extent and location of the damage.
